New York State Department of Transportation

PIA Red Flag NB23U4W023

BIN: 1065318

Location: Span 231, Girder G19 at Pier 230.

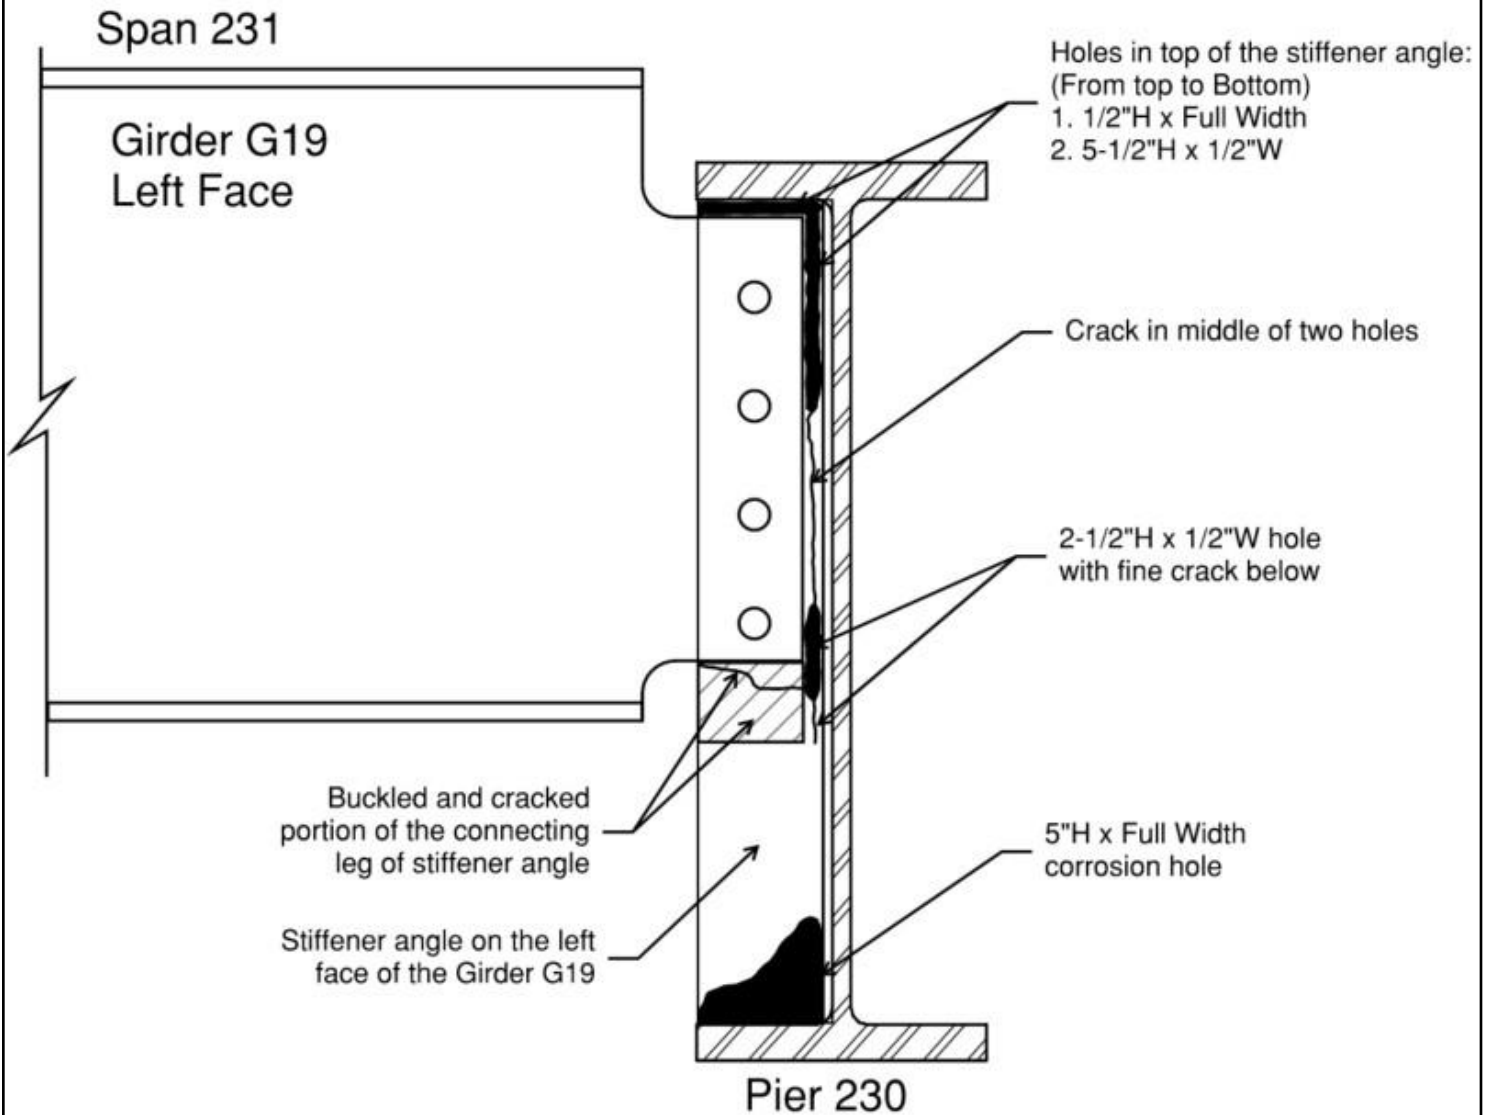
Photo Number: 2

1. The connecting leg of the stiffener angle has a 1/2"H x full width hole in the upper side of the connecting leg, above the girder web.

2. The portion of the connecting leg near the heel of the angle, parallel to the girder web end vertical edge, has two holes
(i) 5-1/2"H x 1/2"W adjacent to the top corner of the girder web end, and
(ii) 2-1/2"H x 1/2"W hole with a 2"L fine crack adjacent to the bottom corner of the girder web end.
The portion between these two holes is completely cracked.

3. The connecting leg below the girder web is buckled out of plane and has a horizontal crack at the center of the height of the buckled area.

4. There is a large hole (approx. 5"H x full width) at the base of the connecting leg, above bottom flange of the pier cap of Pier 230, on the Span 231 side. (See Sketch Photo No.2 and Photo Nos. 8, 9, and 10).

SKETCH FOR PIA RED FLAG # NB23U4W023
SPAN 231, GIRDER G19 AT PIER 230
(LOOKING RIGHT)
N.T.S

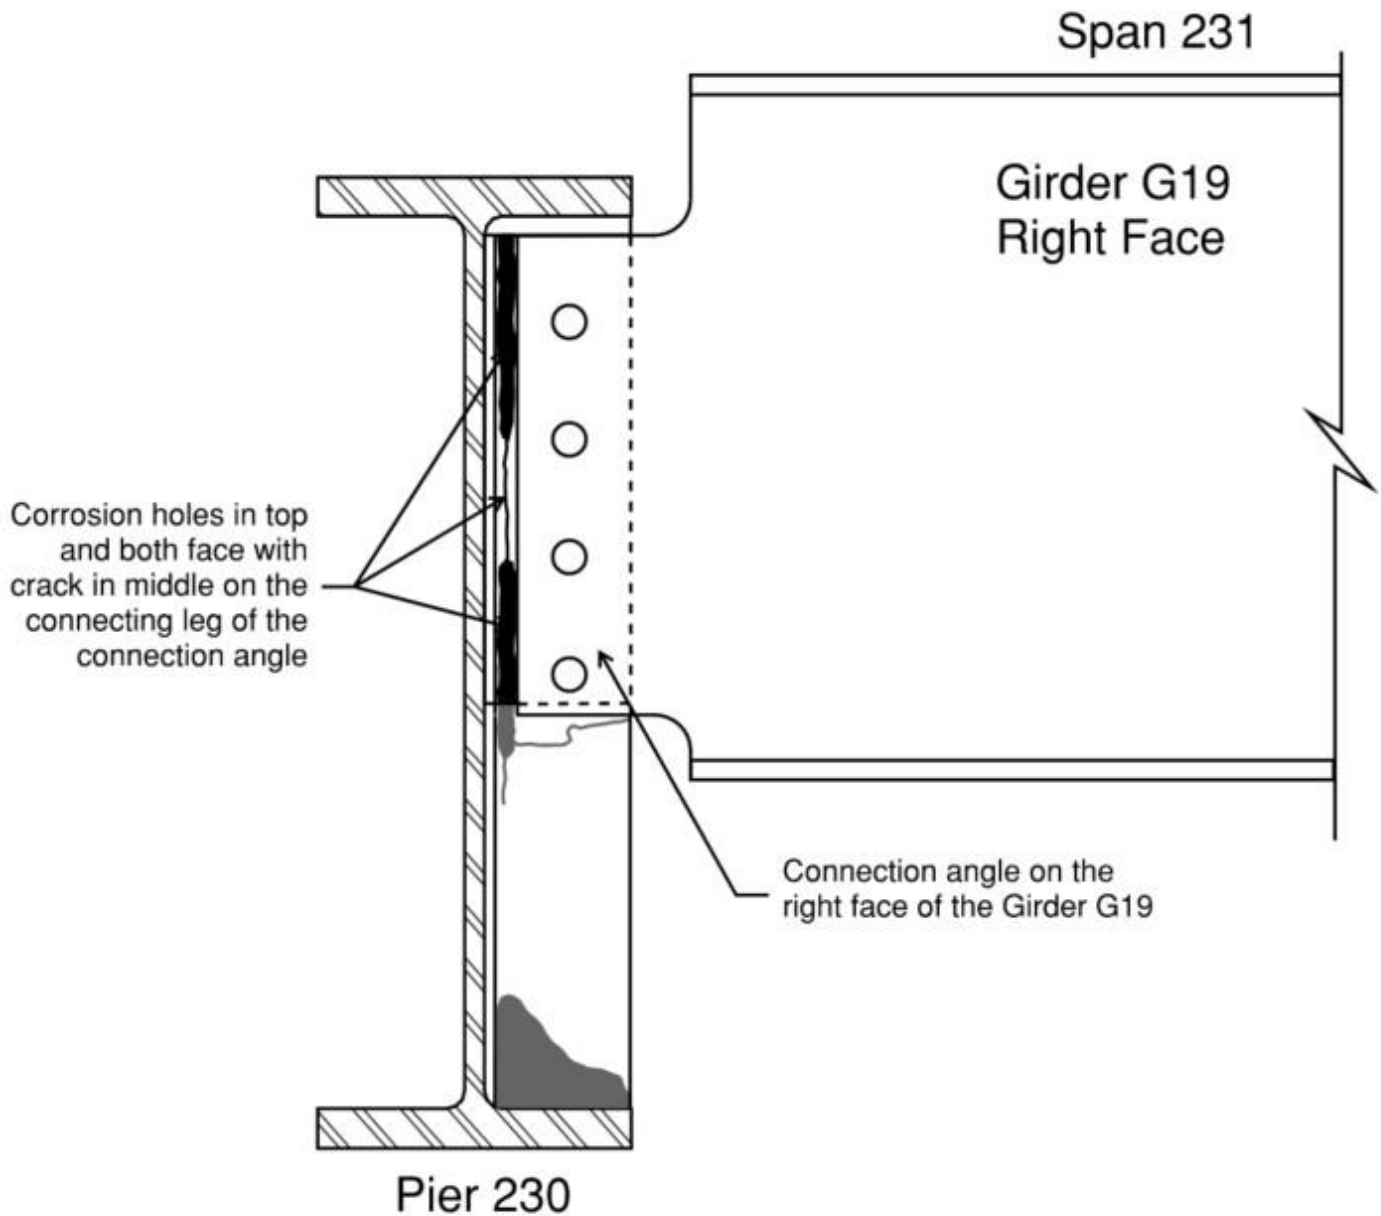
Photo Number: 3

1. The connecton angle exhibits large corrosion holes in the top and bottom side of the connecting leg. The portion of steel between two holes is completely cracked, resulting in a complete disconnection of the connection angle to the Pier Cap (See Sketch Photo No.3 and Photo No. 7).

SKETCH FOR PIA RED FLAG # NB23U4W023
SPAN 231, GIRDER G19 AT PIER 230
(LOOKING LEFT)
N.T.S

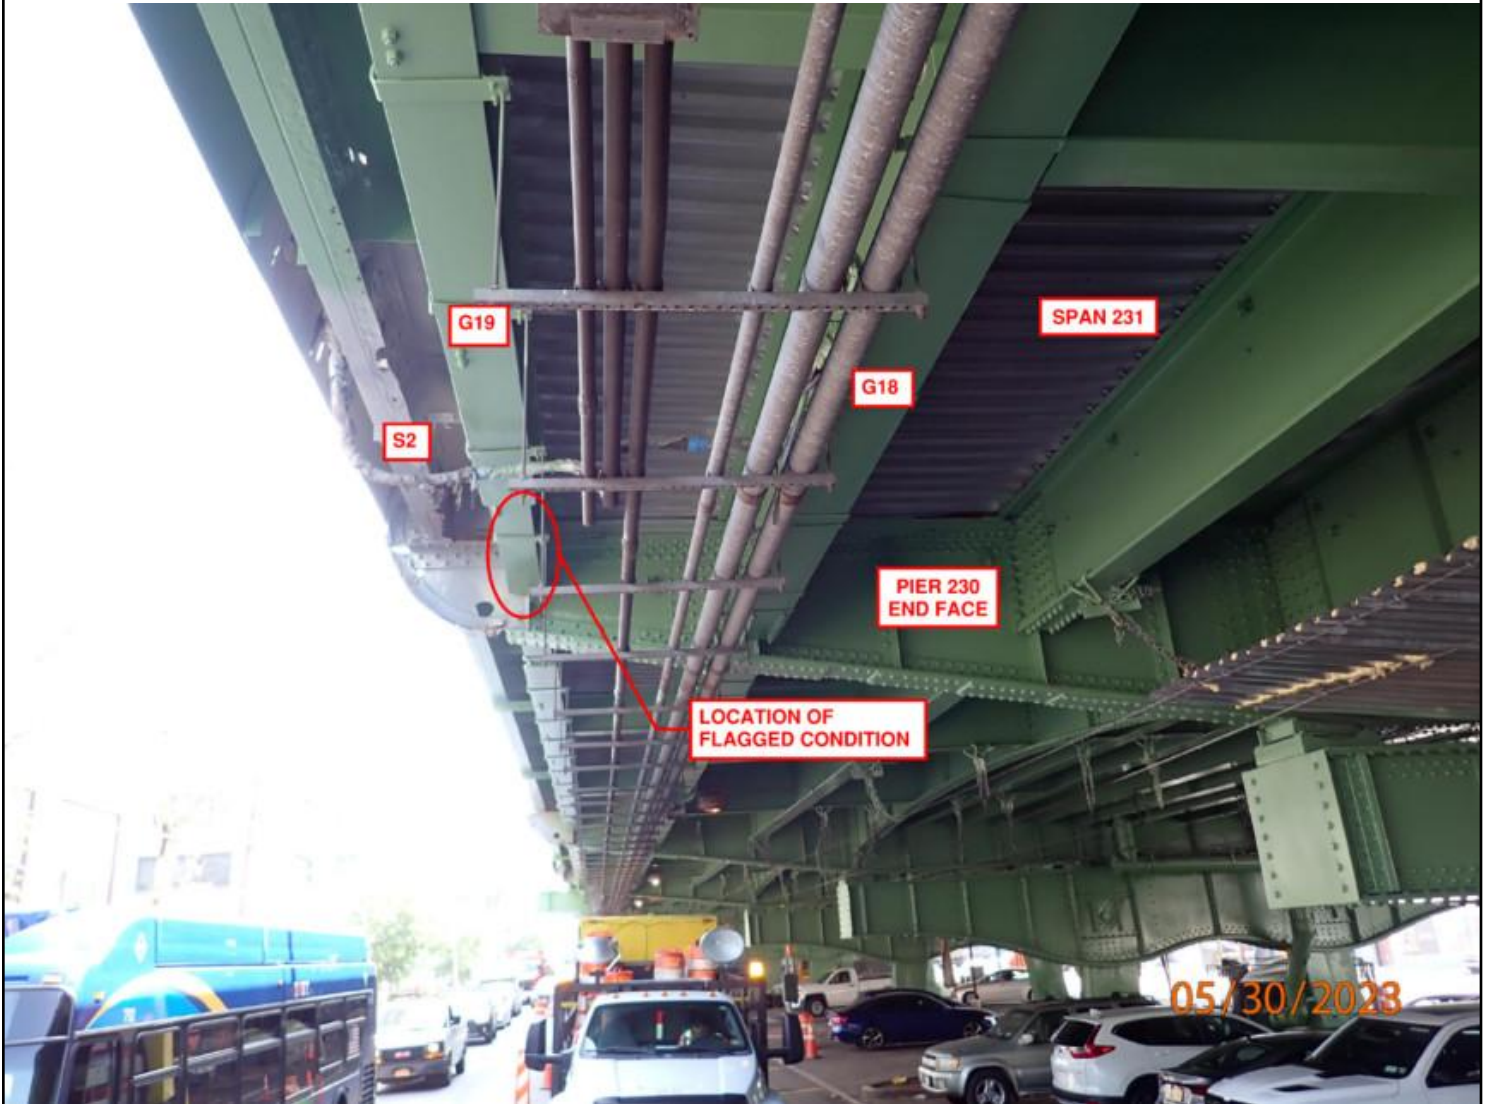
Photo Number: 4

Attachment Description: General View of Flag Location. Looking Begin - Up.

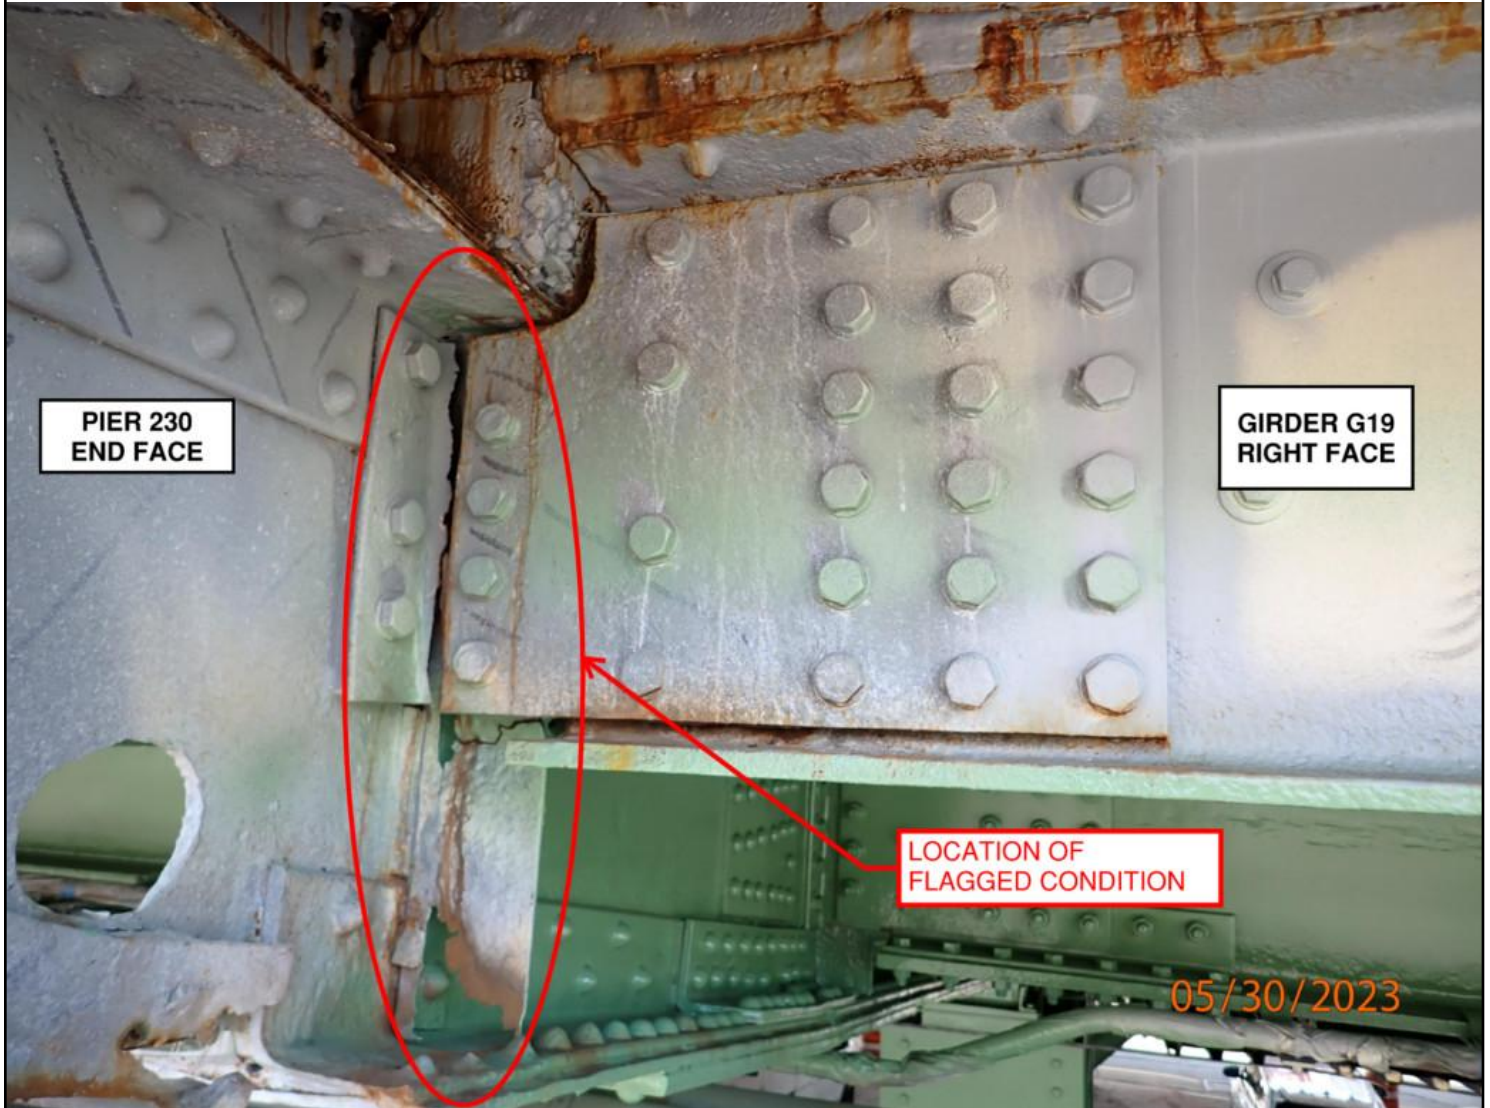
Photo Number: 5

Attachment Description: General View of Girder G19 right face. Looking Begin-Left.

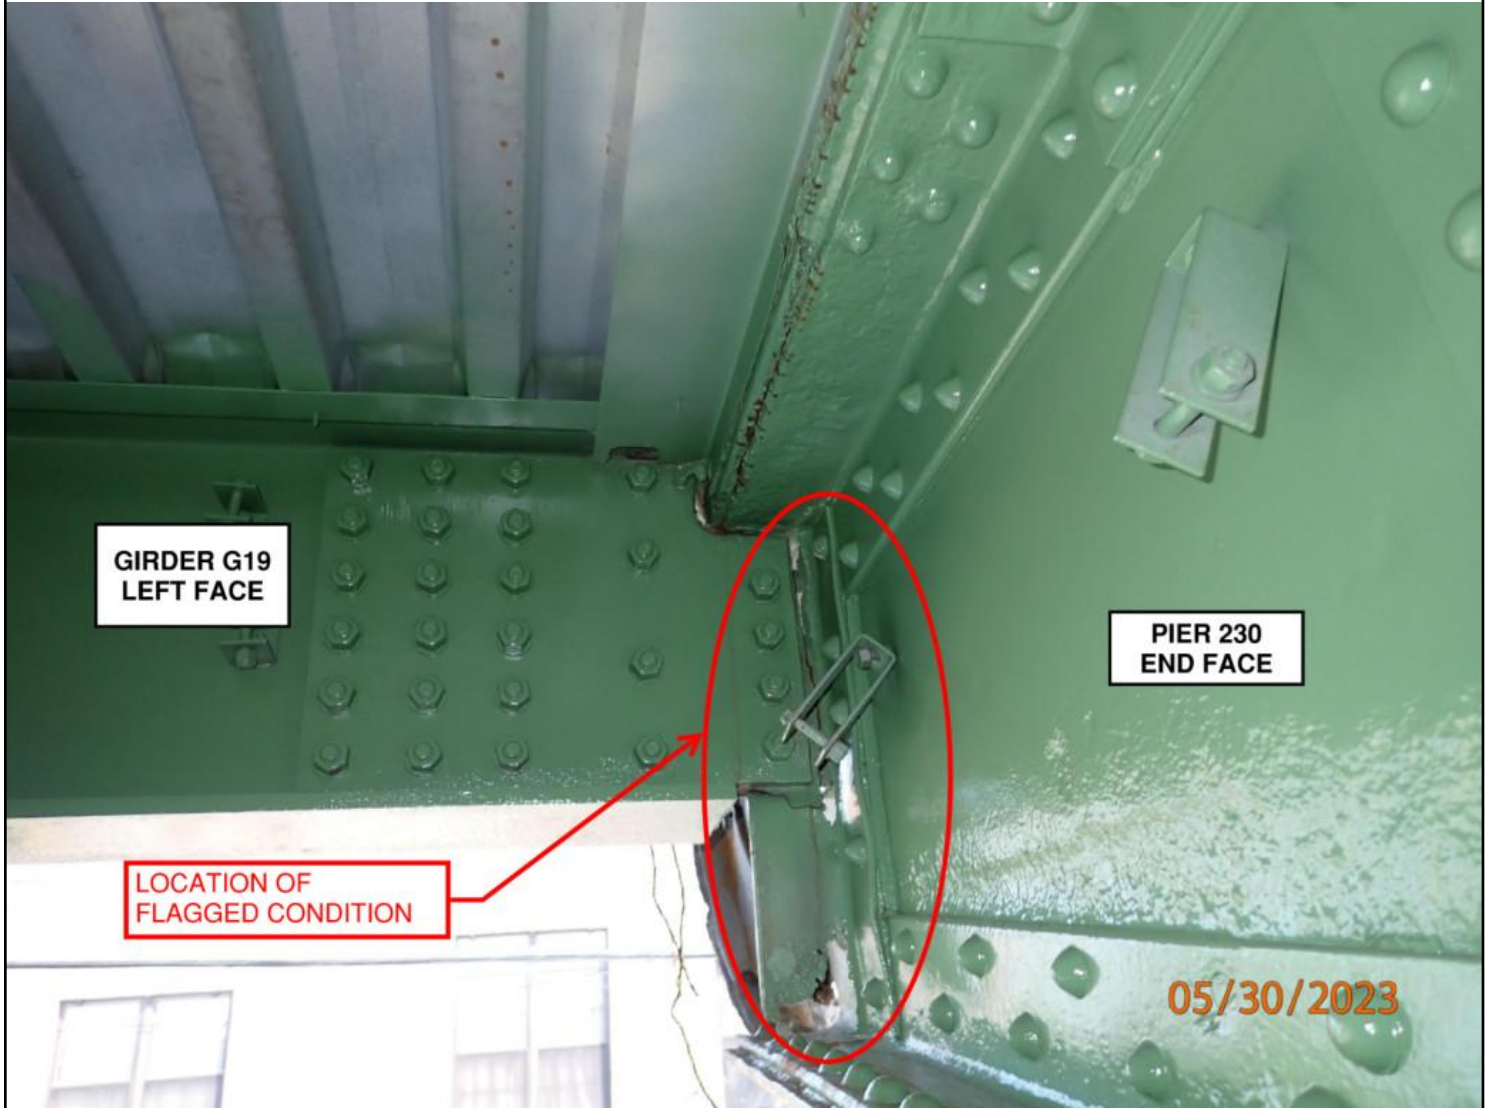
Photo Number: 6

Attachment Description: General View of Girder G19 left face. Looking Right.

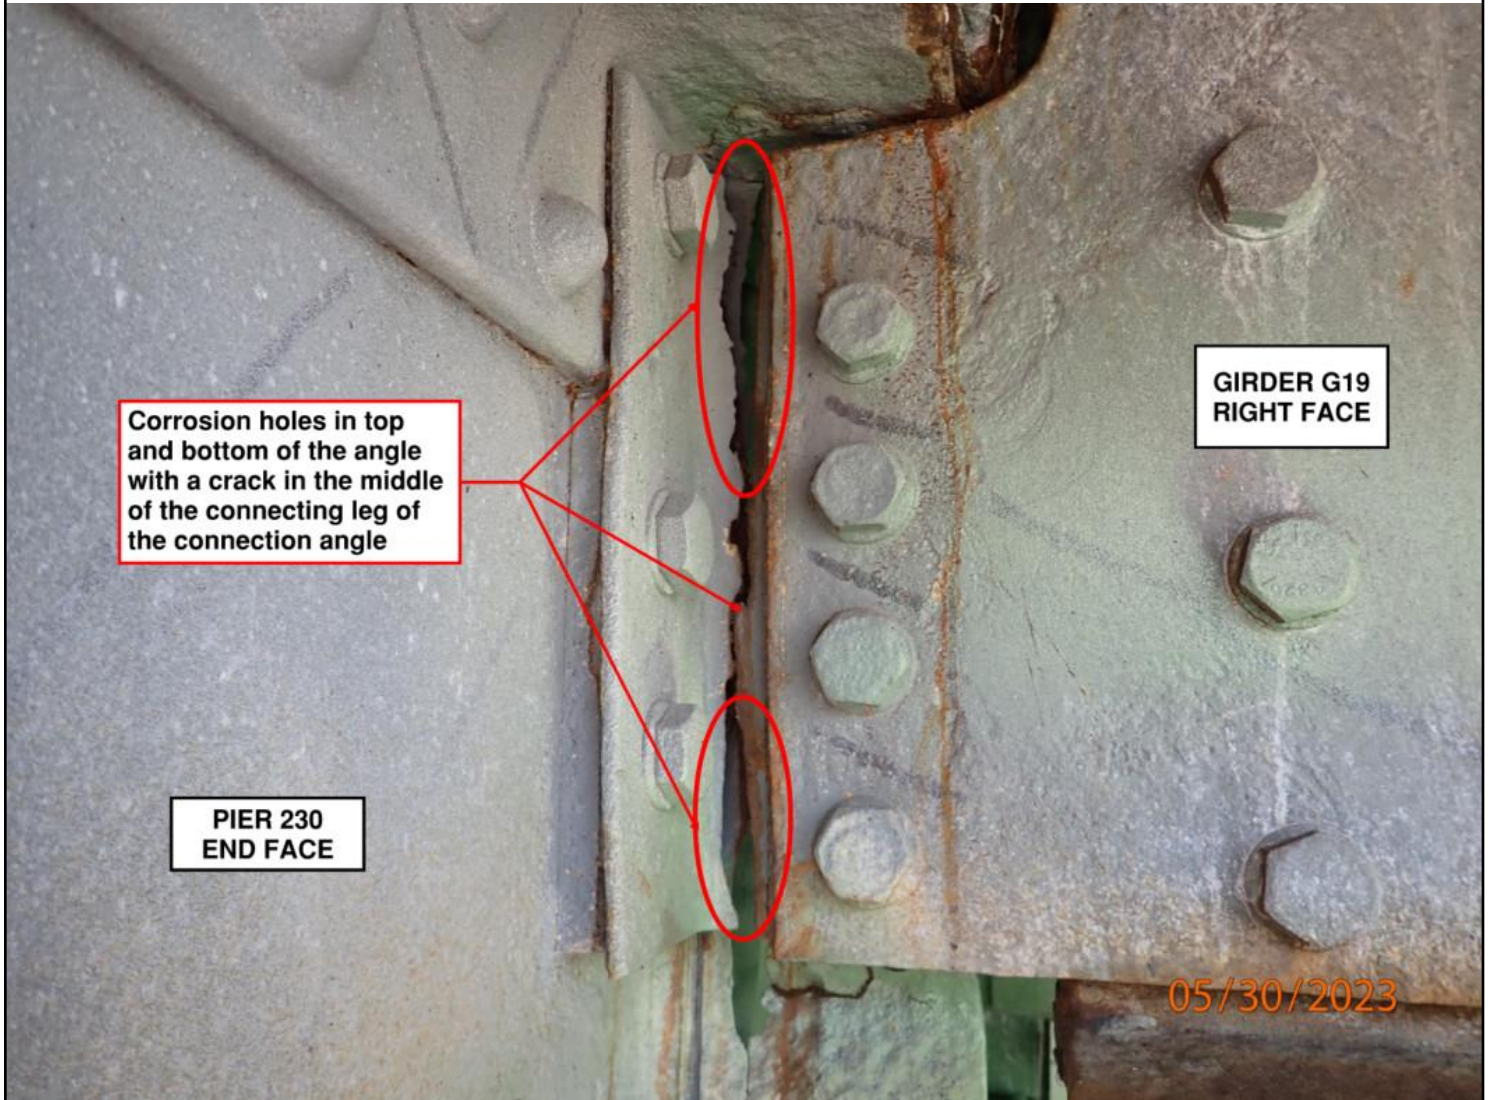
Photo Number: 7

Attachment Description: Connection angle exhibits large corrosion holes in the top and bottom side of the connecting leg with crack in middle. Looking Left.

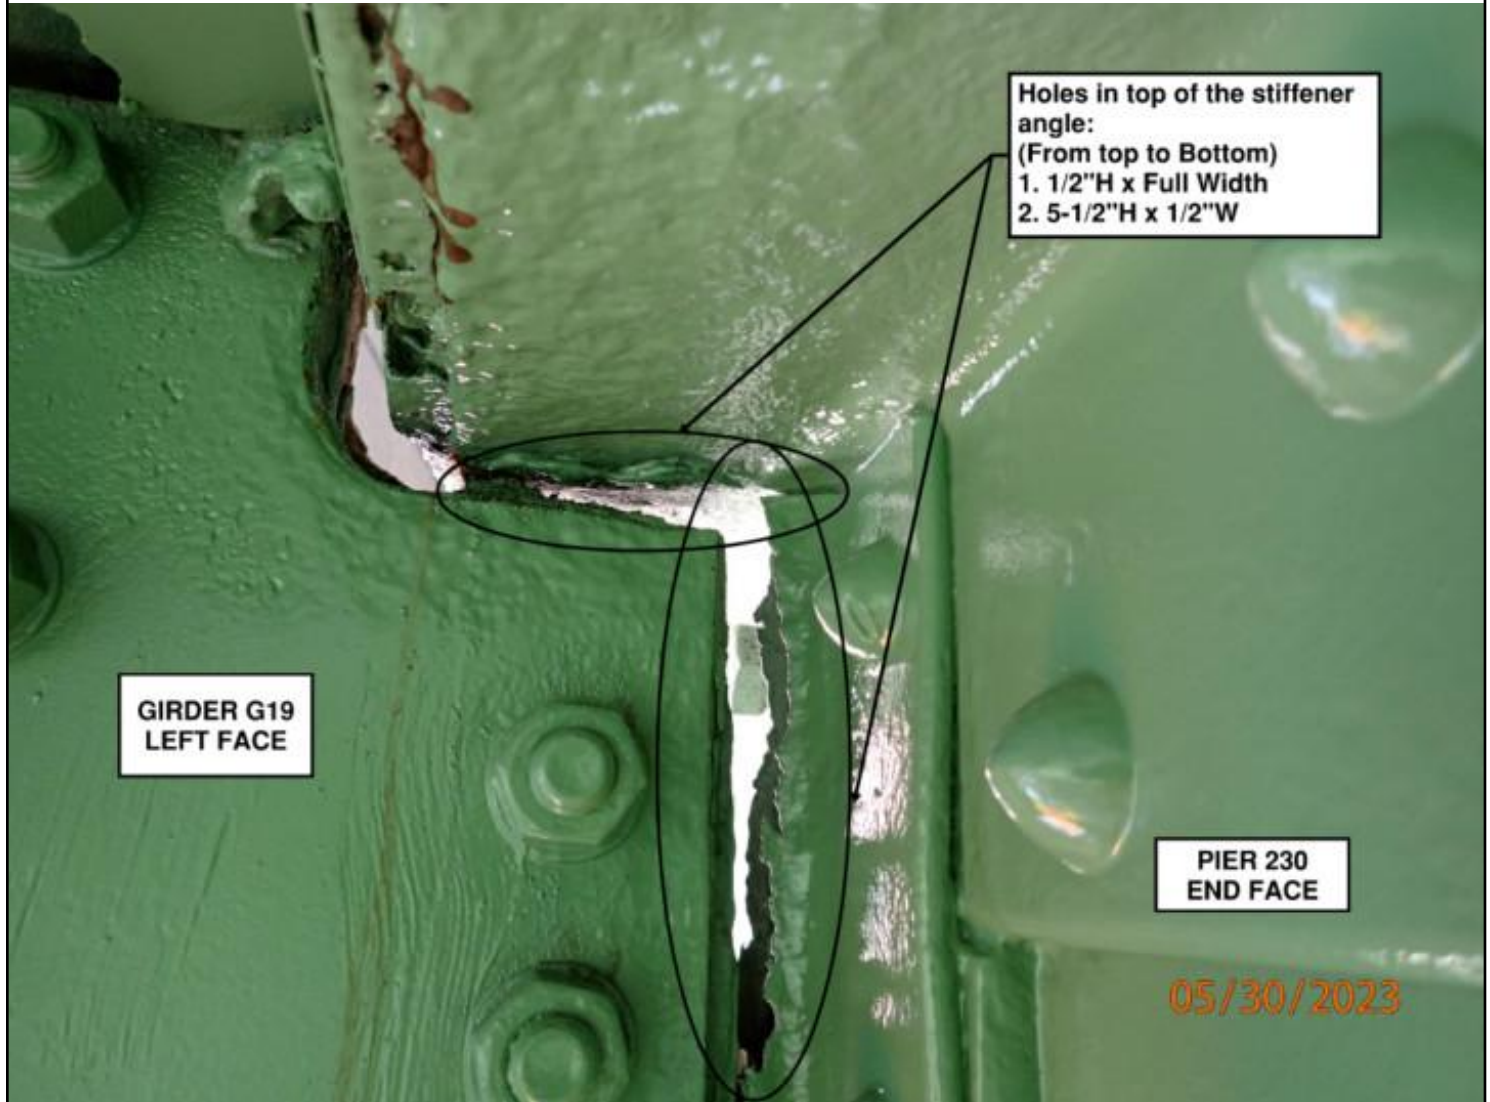
Photo Number: 8

Attachment Description: Connecting leg of the stiffener angle has a 1/2"H x full width hole in top and a 5-1/2"H x 1/2"W hole adjacent to the top corner of the girder web end. Looking Right.

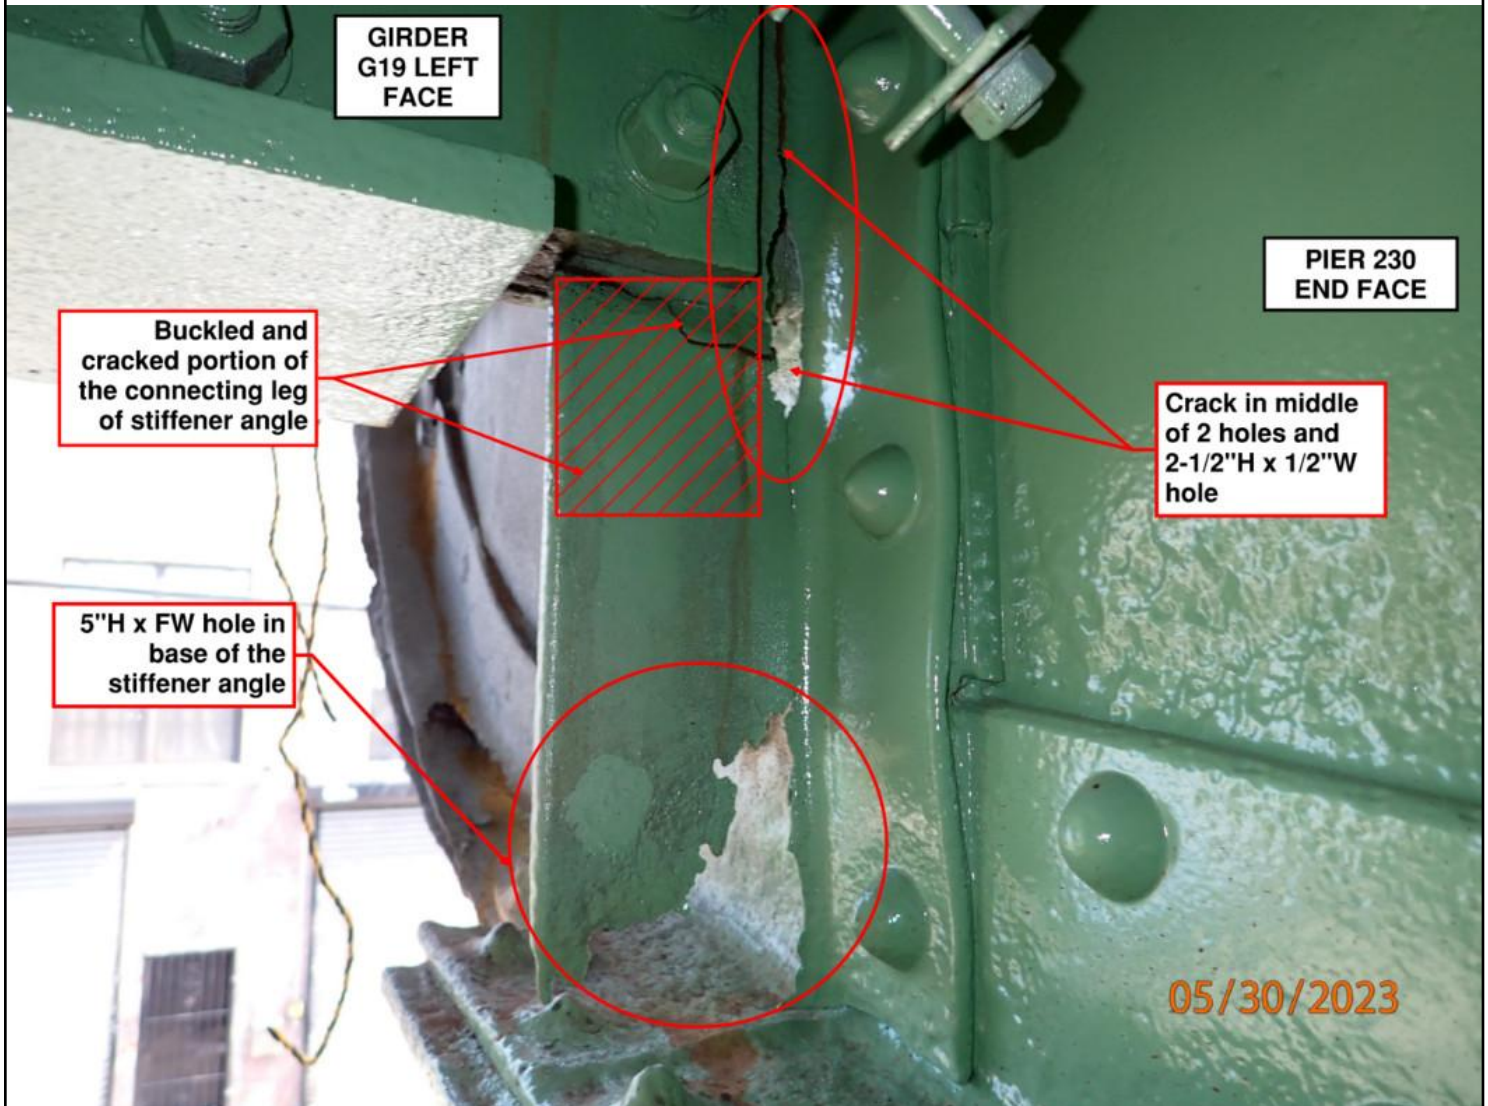
Photo Number: 9

Attachment Description: Connecting leg of stiffener angle has a hole to the top corner, and a 2-1/2"H x 1/2"W hole with 2"L fine crack to the bottom corner of the girder web end. The portion between these two holes is completely cracked. Connecting leg of stiffener angle below the girder web is buckled out of plane and has a horizontal crack at the center of the height of buckled portion. Looking Right.

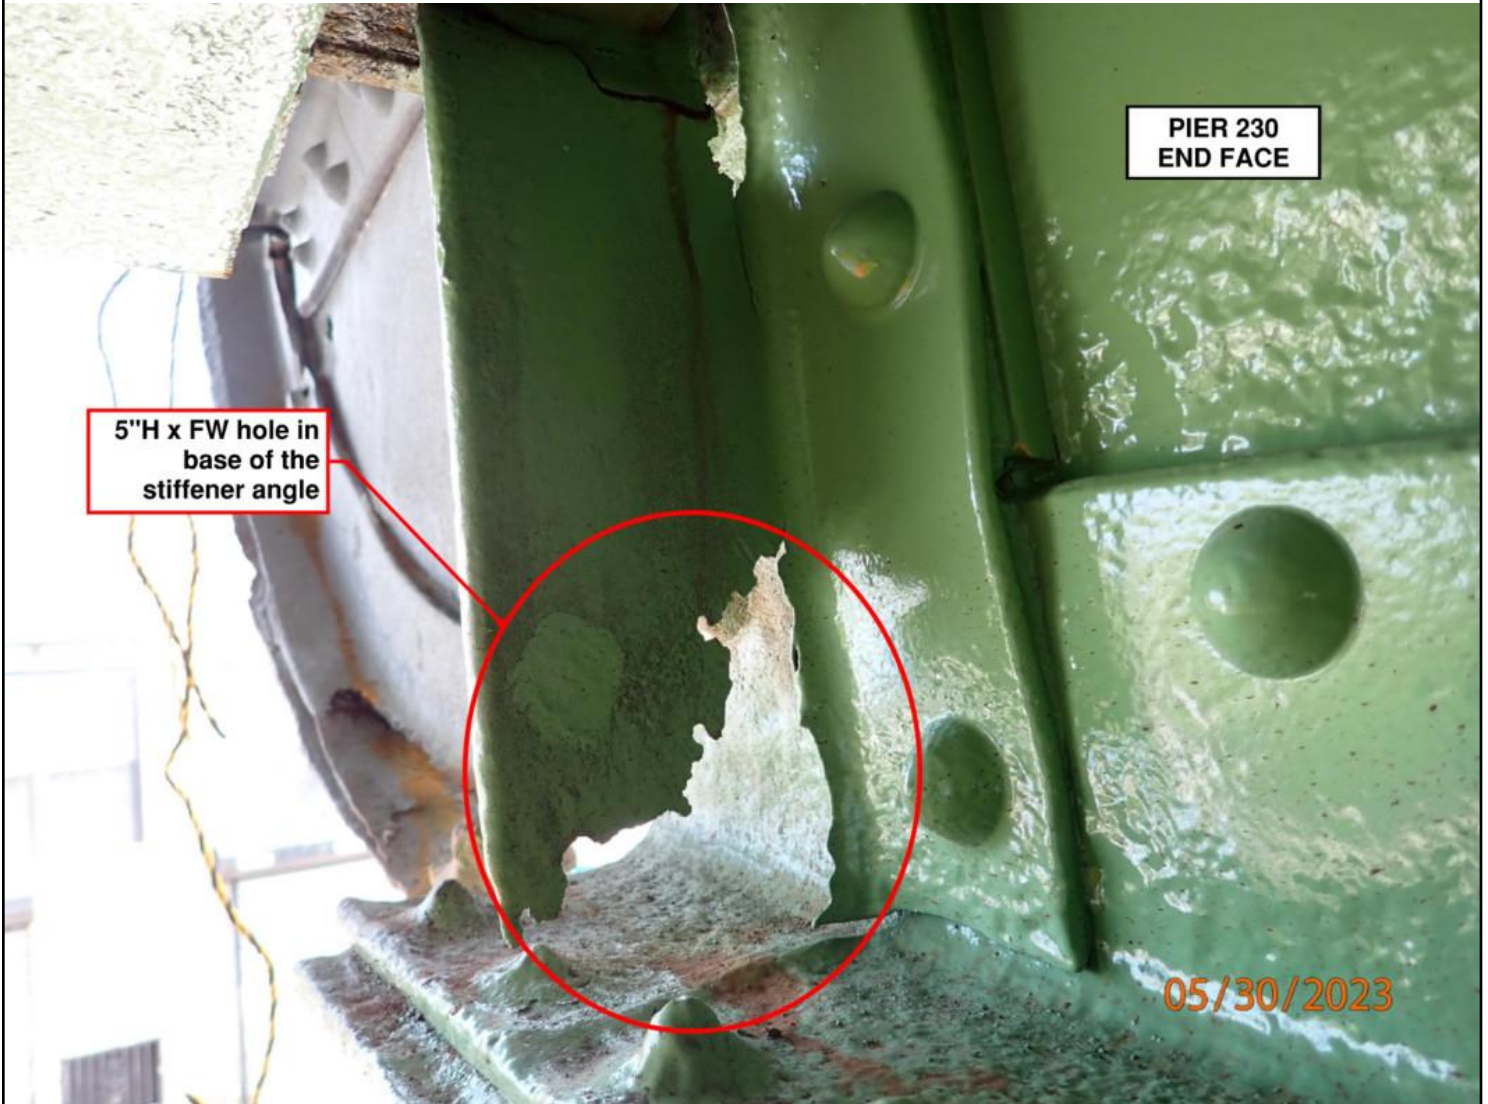
Photo Number: 10

Attachment Description: : Stiffener angle has a large hole (approx. 5"H x full width) at the base of the connecting leg, above the bottom flange of the pier cap of Pier 230, on the Span 231 side. Looking Right.
